# AN ADDENDUM TO THE PREVIOUSLY ADOPTED MITIGATED NEGATIVE DECLARATION FOR LEARN MINOR SUBDIVISION, PDS2002-3200-20571 (TPM-20571RPL)

FOR PURPOSES OF CONSIDERATION OF NEWSOM OPEN SPACE VACATION PDS2022-VAC-22-003, PDS2022-ER-00-10-008A

## Environmental Review Update Checklist Form For projects with Previously Approved Environmental Documents

# Biological Assessment for the County of San Diego Tentative Parcel Map 20571 in the Cuyamaca Mountain Community

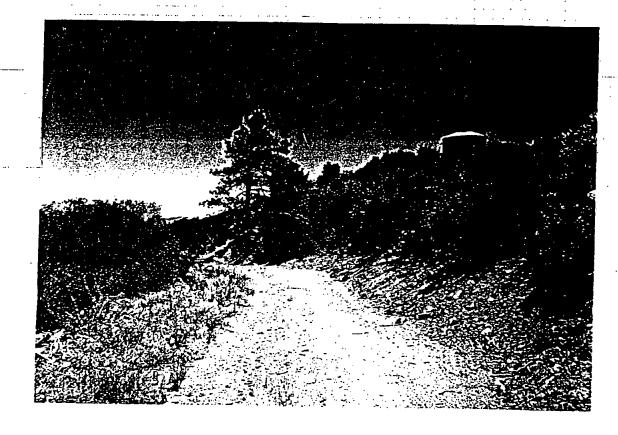
Photograph 1: Coulter pine, manzanita, and scrub growth on jeep trail just north of the well site. Notice the water tank.

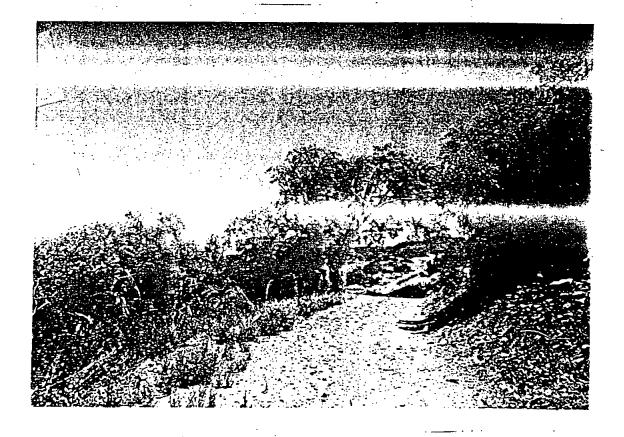
Photograph 2: Black oak, along the jeep trail, northwest portion of Parcel 4

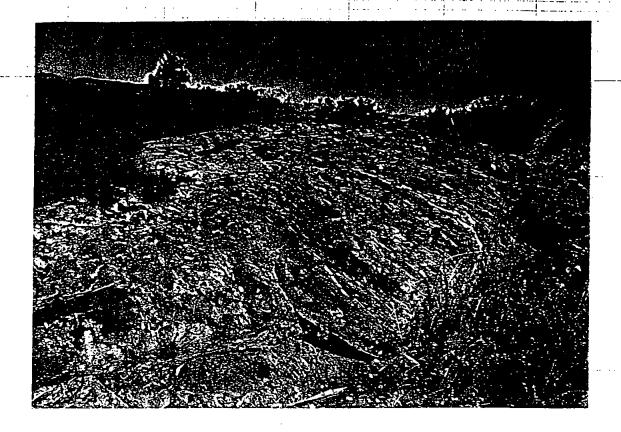
Photograph 3: Typical outcrop of metaplutonic rock, in northwest portion of Parcel 4

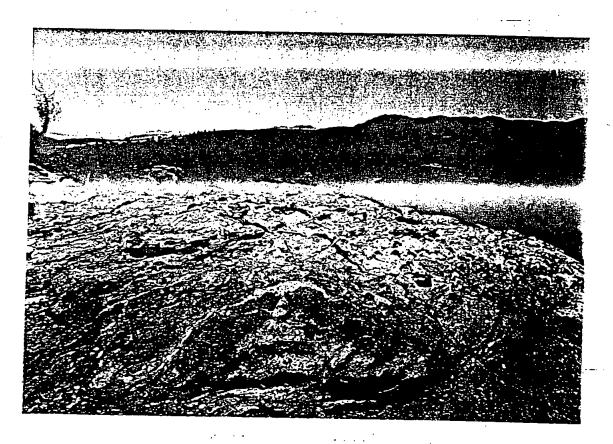
Photograph 4: View to southwest, toward Cuyamaca Peak, from locality east of parcel 3. Gneiss here is partially metasedimentary.

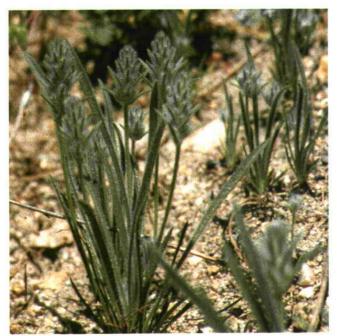
**Plantago aristata** — This species is found as an adventive weed on disturbed soils in the lower foothills and below. Gordon Pratt (personal communication to the author, 2000) opines that he is not familiar with this species of *Plantago* and that he knows of no Euphydryas editha quino utilization of this species.

**Plantago erecta** — The primary food or host plant of the larvae of the Quino Checkerspot Butterfly. This species is replaced at higher elevations by the form to the right.

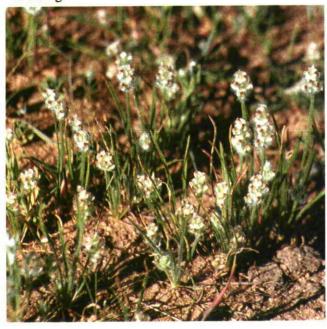
**Plantago patagonica** — two views below, one dried inflorescence and a living specimen. This is the species that replaces *P. erecta* at higher elevations. This is apparently the primary host plant of *Euphydryas editha quino* at the higher elevations of its range (Pratt, 2000). Photograph of a specimen
